Frost Fish Creek Restoration Assessment Report

Chatham, Massachusetts

January 3, 2019

Prepared by the Association to Preserve Cape Cod's Restoration Coordination Center
for the Chatham Conservation Foundation

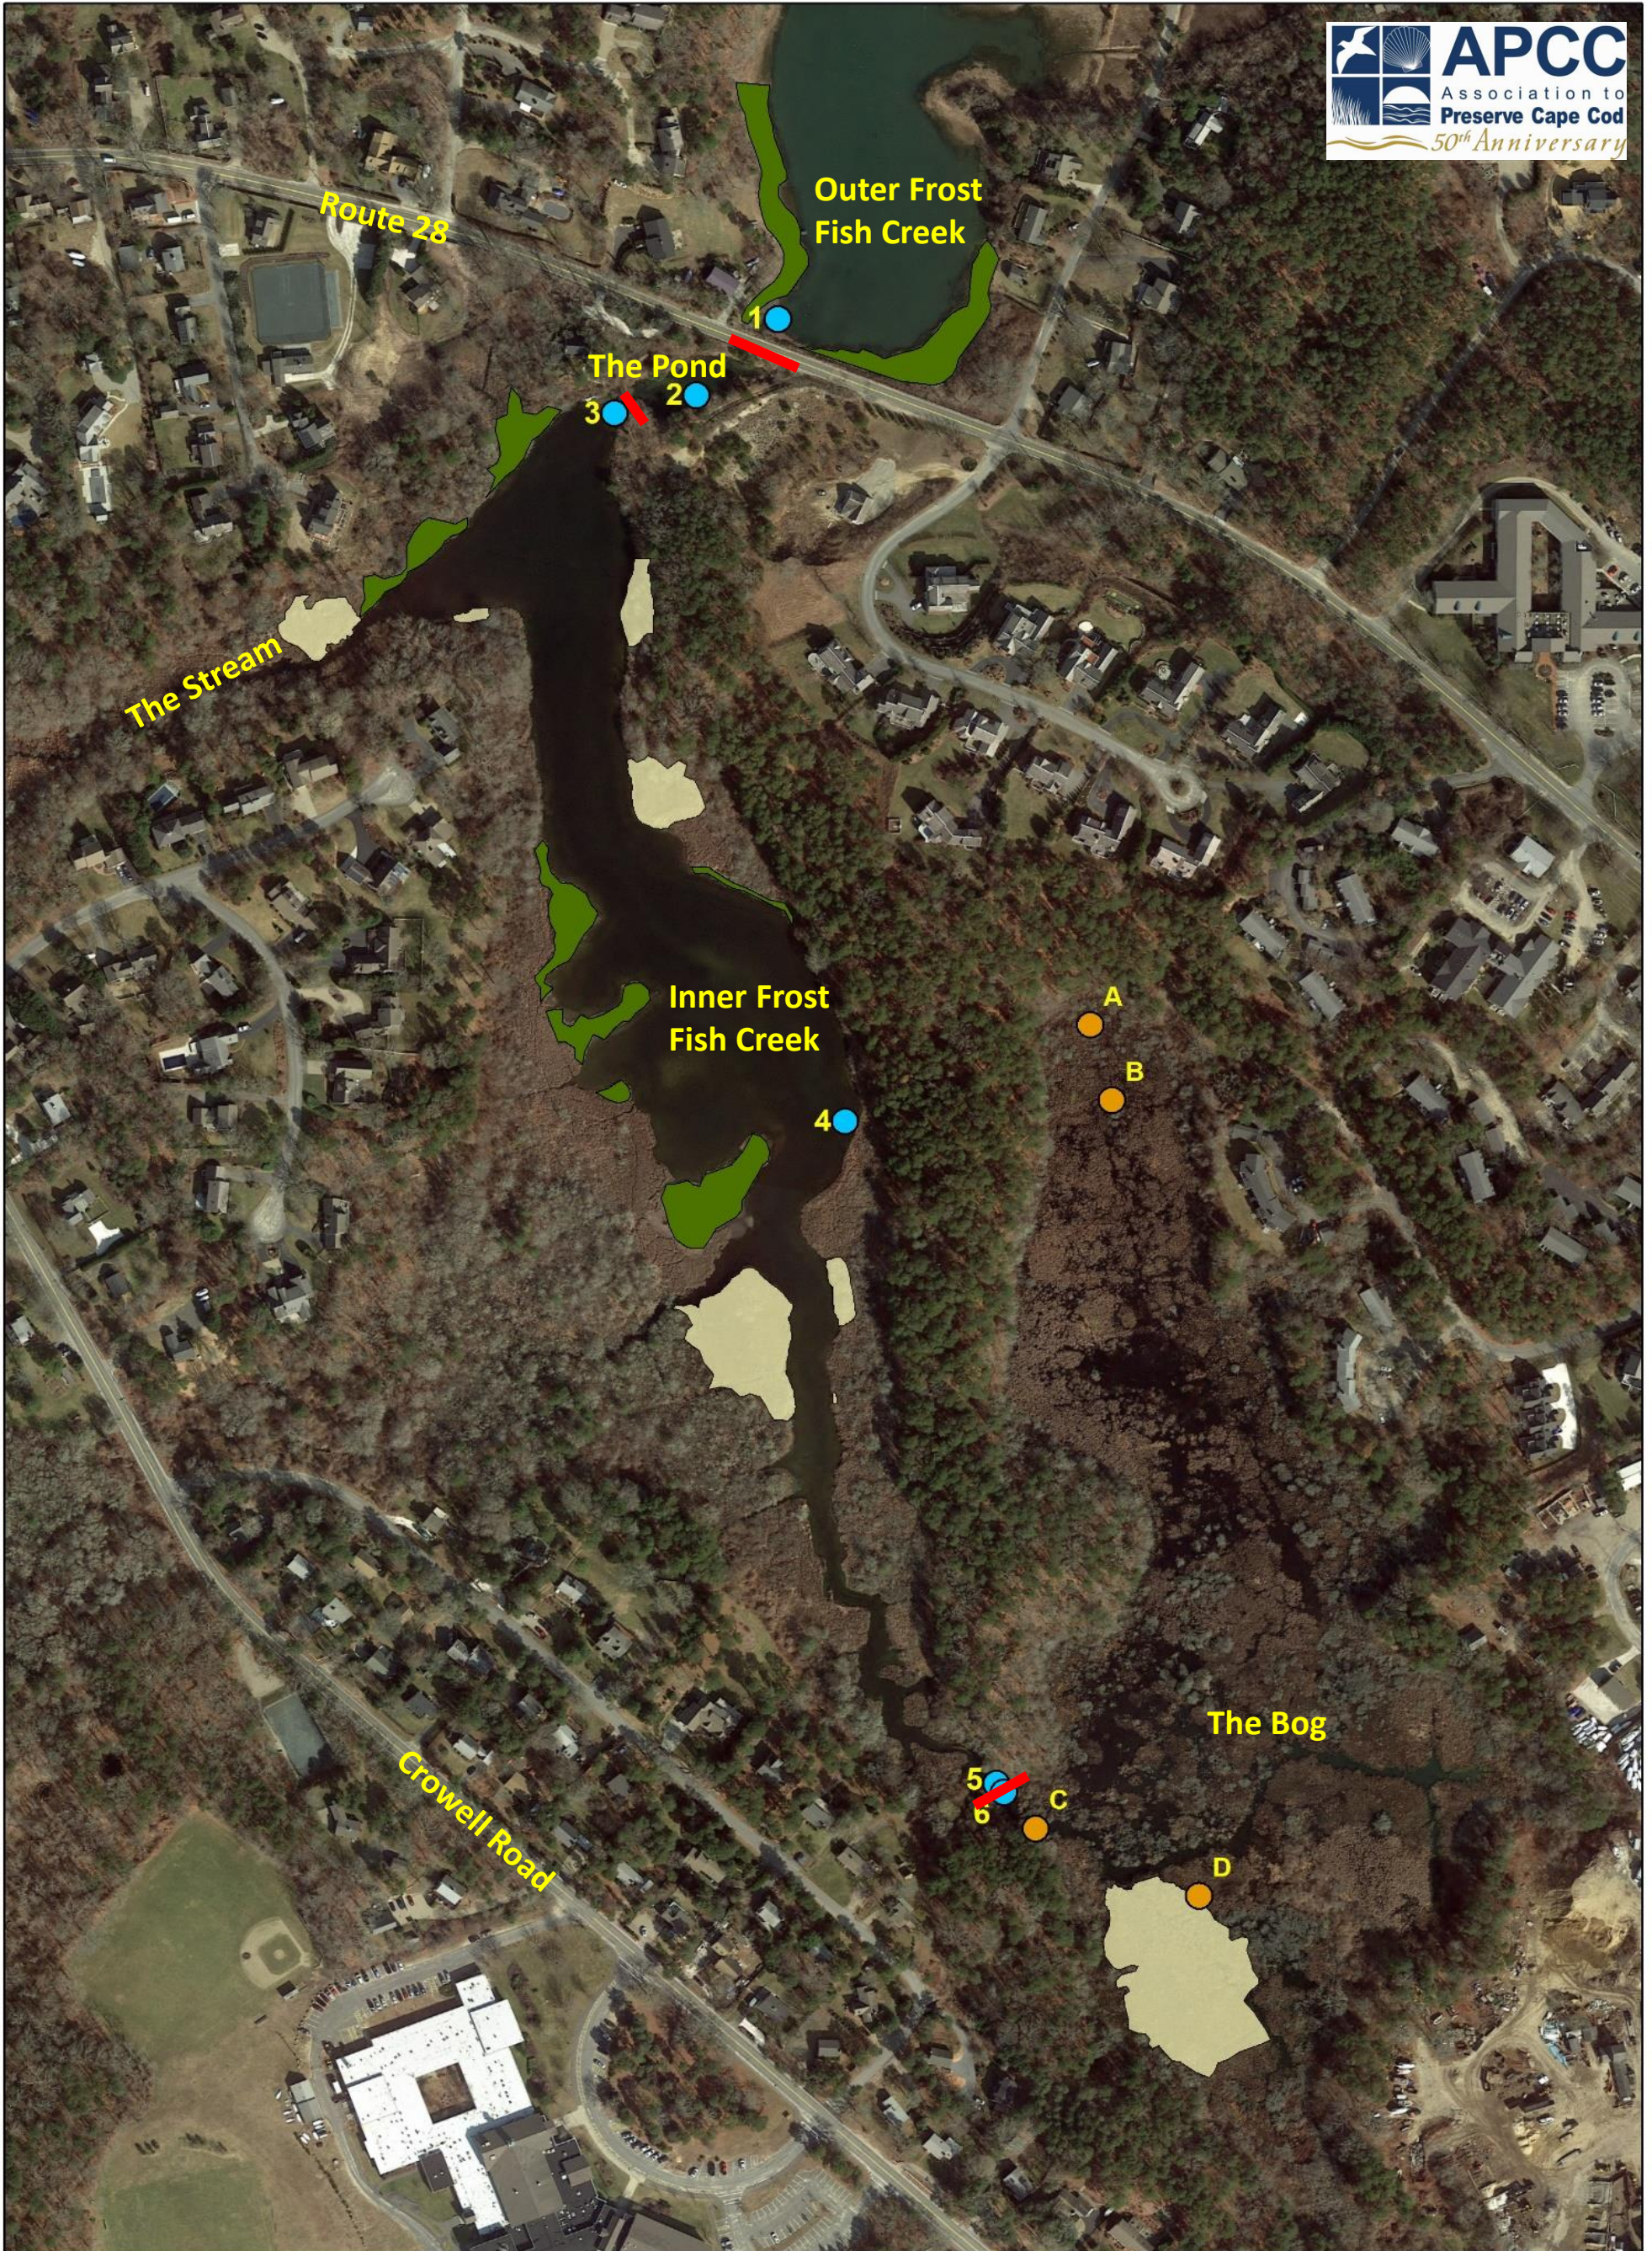
Appendix A. Field Survey Map

A third hydrologic restriction exists approximately 2,300-ft further upstream where tidal influence is stopped and water surface elevation is held artificially high in the bog area by another earthen berm fitted with a corrugated metal culvert and concrete weir structure. Water surface elevation in the bog can be controlled by adding or removing wooden weir boards. The water control structure at this site appears to be in functional condition although the metal culvert pipe is rusted and may not be structurally sound throughout its length beneath the berm. Due to complete separation from any tidal influence logger FFC6 located in the bog just upstream of the third restriction is not included in the following discussion of results unless specifically referred to. See Field Survey Map for locations of tidal restrictions indicated by red bars (Appendix A).

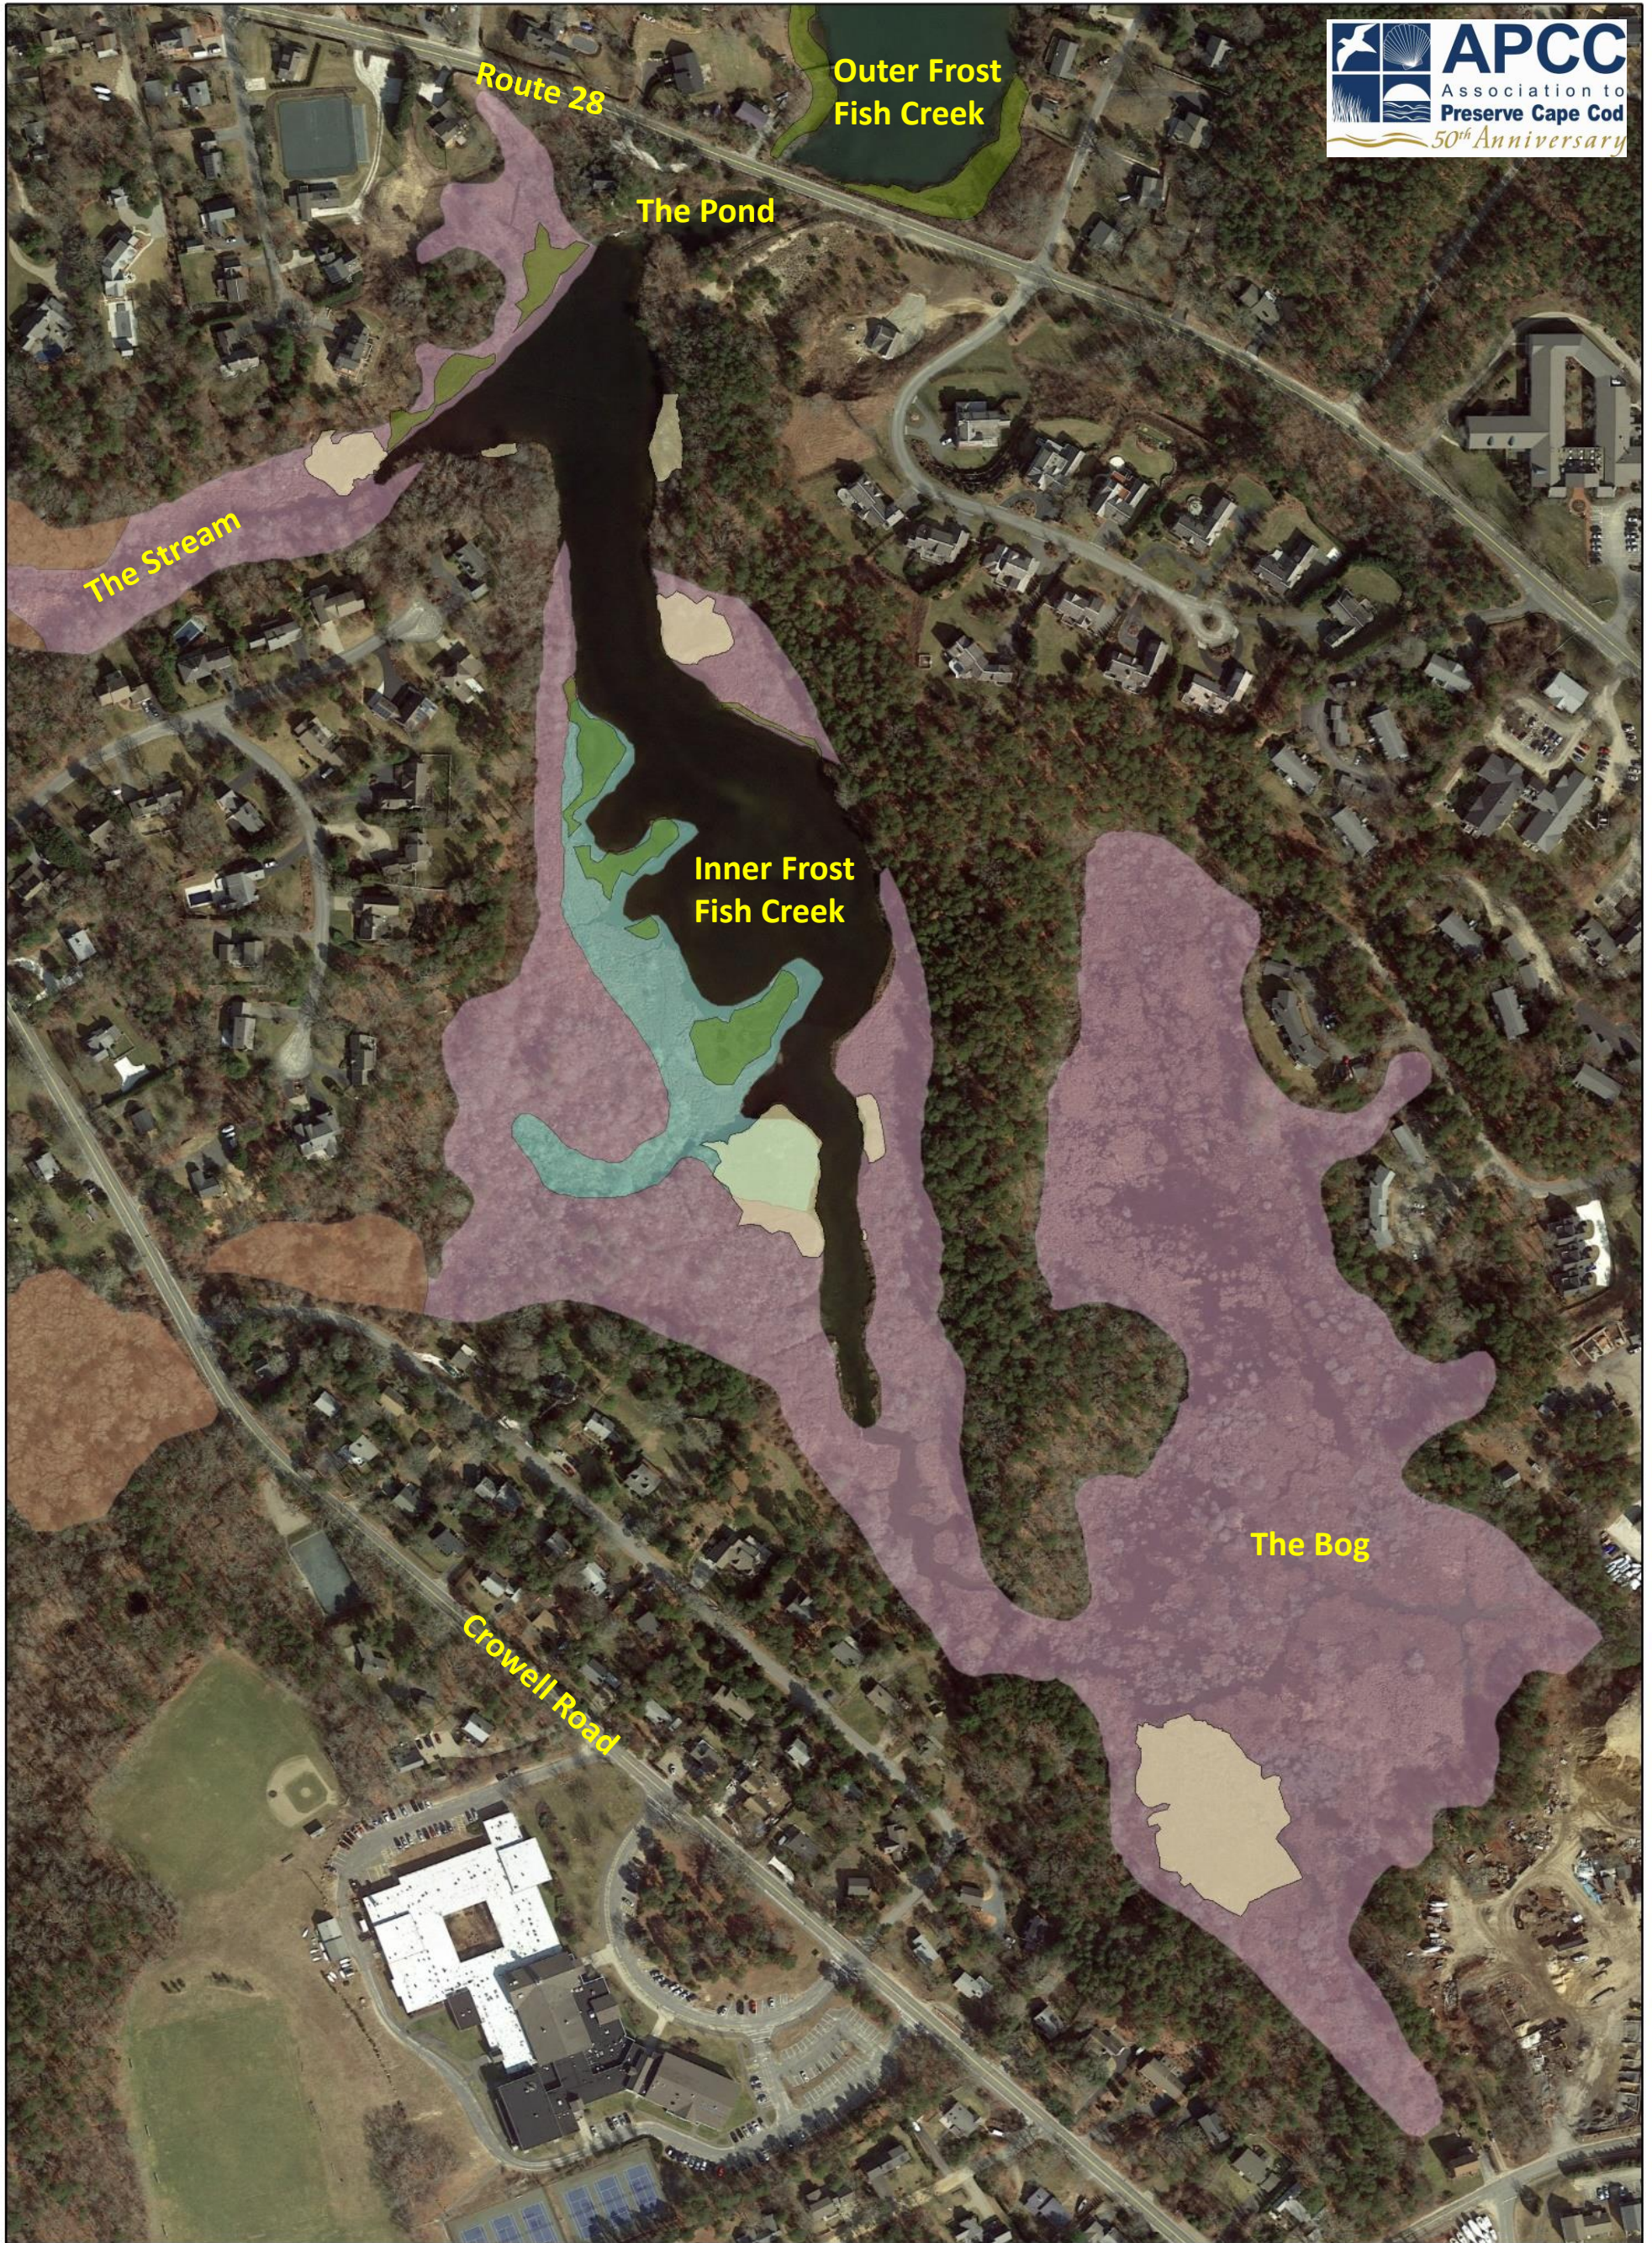
Appendix C. Vegetation Survey Map

Based on field and aerial imagery-based surveys it was confirmed that the shorelines of Frost Fish Creek are comprised of diverse wetland vegetation communities that transition from salt marsh to freshwater marsh as you move upstream and inland. Using the Cape Cod Commission's Wetlands GIS datalayer,⁹ which is based on the MADEP Wetlands layer, the following wetland types were identified in the project area: shrub swamp, shallow marsh or fen, and wooded deciduous swamp. During our field survey, the entirety of the upper bog area was confirmed to be freshwater shrub swamp. This wetland type extends throughout much of the inner Frost Fish Creek area. However, based on our field surveys, some of the areas in the Wetlands datalayer labeled as shrub swamp and shallow marsh or fen were instead found to be salt marsh, which is not surprising since this data layer was created based on aerial imagery with only limited field confirmation. The shrub swamp on the western and northern shores in particular was found to be interspersed with patches of salt marsh. These larger areas of salt marsh were noted, but not mapped during our field survey. We also noted salt marsh cordgrass, *Spartina alterniflora*, along much of the immediate shoreline edge, although not extending inland away from water's edge in most cases. To capture the approximate location and extent of salt marsh, APCC used aerial imagery along with field observations to map the larger areas of salt marsh using ArcGIS Desktop software and were included on the Field Survey Map (Appendix A). These areas of salt marsh were then overlaid on the Wetlands datalayer showing approximate extent of shallow marsh/fen, shrub swamp and wooded swamp in the Vegetation Survey Map (Appendix C).

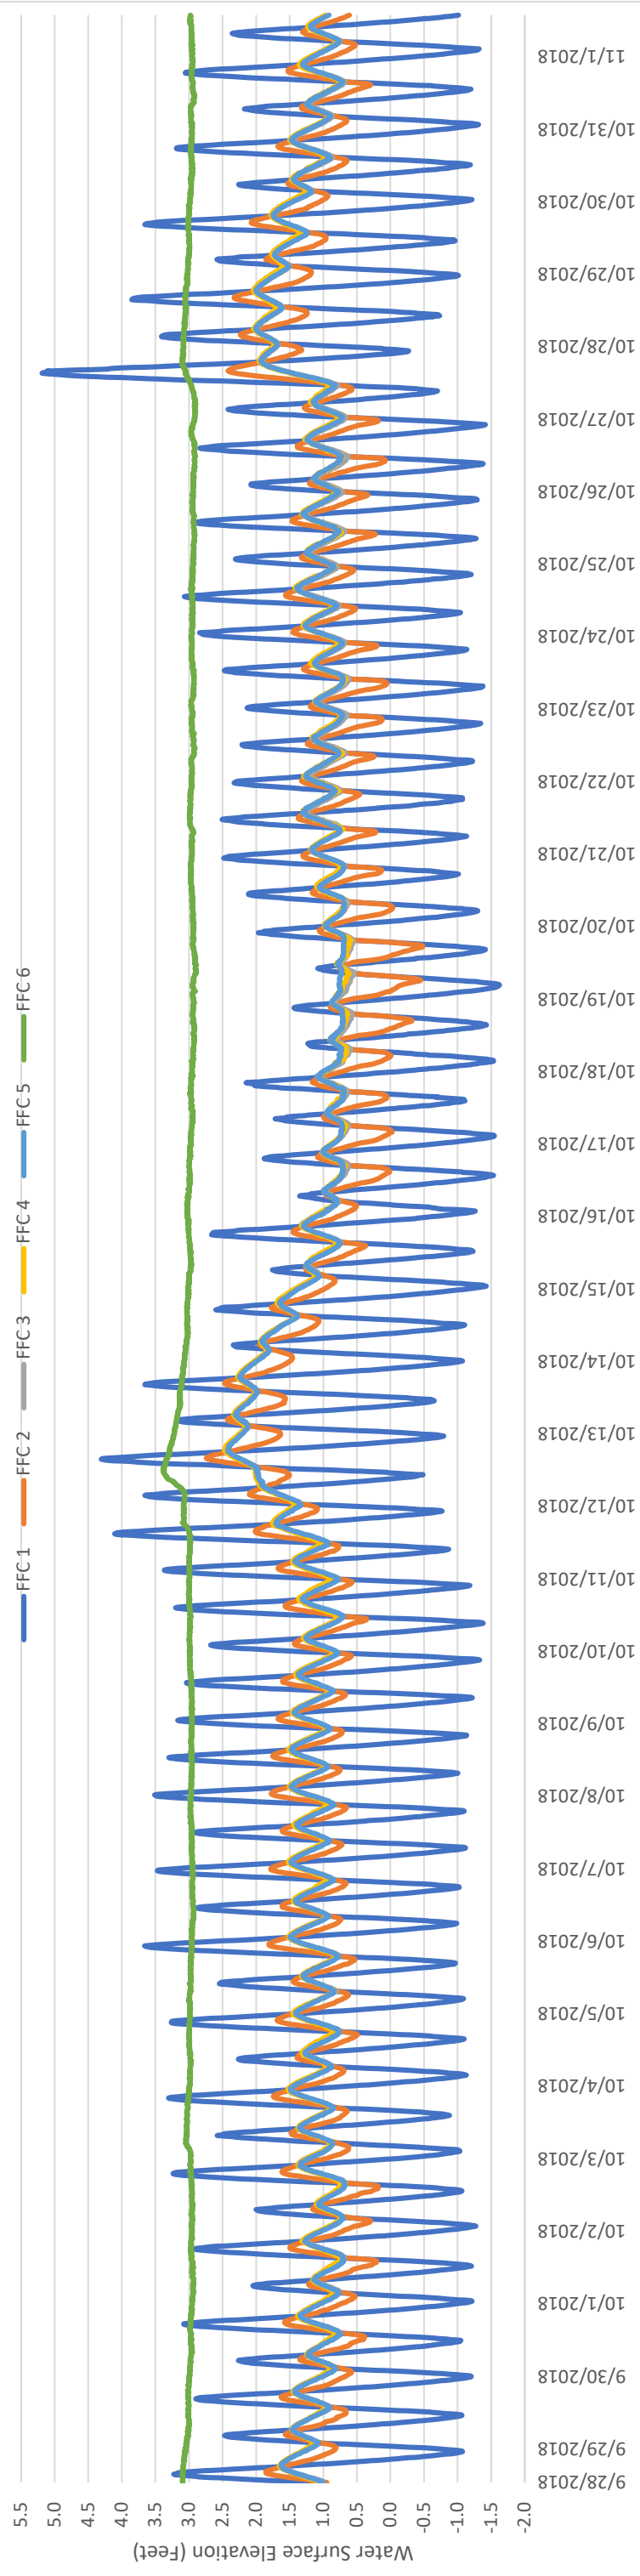
Frost Fish Creek Water Surface Elevation Plot Depicting Tidal Restrictions at Route 28 and Various Points Further Upstream

The resulting graph of water surface elevation (WSE) across all six locations confirms expected tidal restrictions between logger locations (Appendix E). The following table (Table 1) summarizes differences in average, maximum, minimum, and range of water surface elevation between monitoring locations in vertical feet relative to the NAVD 1988 vertical datum. Note that the total range as reported here differs significantly from the average daily range within each tidal cycle. For example, the average daily range in water surface elevation for logger FFC1 is approximately 4-ft, ranging in elevation from around 3ft to 1ft as opposed to the 6.81ft total range of the entire month-long data set, which accounts for the difference between the most extreme high and low tide events. To ascertain approximate average tidal range, or prism as it is often referred, refer to the WSE graph in Appendix E.

As expected, the most significant restriction was identified at the crossing of Route 28 where average tidal range for the full deployment period was reduced by 3.58-ft when comparing data from logger FFC1 with that of FFC2. At the Route 28 crossing, water ebbs and floods with the tides through concrete culverts. According to the 2006 Massachusetts Estuaries Project (MEP) report, there were three 1.5-ft diameter culverts beneath Route 28,⁴ although during our recent survey we only located two functional culverts. The third may be collapsed or clogged and does not appear to be conveying water in any significant amount, thus it is likely that the extent of the tidal restriction has increased since the last hydrologic assessment as documented in the 2003 MEP report.

A secondary tidal restriction was identified at an earthen berm approximately 200-ft upstream from Route 28 where tidal range is further reduced by an additional 1.32-ft based on comparison of average tidal range between loggers FFC2 and FFC3 during our survey period. This second restriction occurs just upstream of the area referred to as “the pond” for this report where water flows swiftly through an earthen berm via a single 30-inch concrete culvert pipe. During our survey we observed evidence that high water may occasionally breach the top of this berm (see photo titled “Pond berm eroded channel”) and found the culvert to be in poor condition as water was observed gurgling out of the top of the culvert pipe and around the concrete weir structure and headwall. It’s also worthy to note that the powerful flow rate through this culvert is a significant hazard to both humans and animals. There is no protective fencing and an animal, child, or adult human could easily be drawn into the culvert if venturing too close during peak tidal flow.

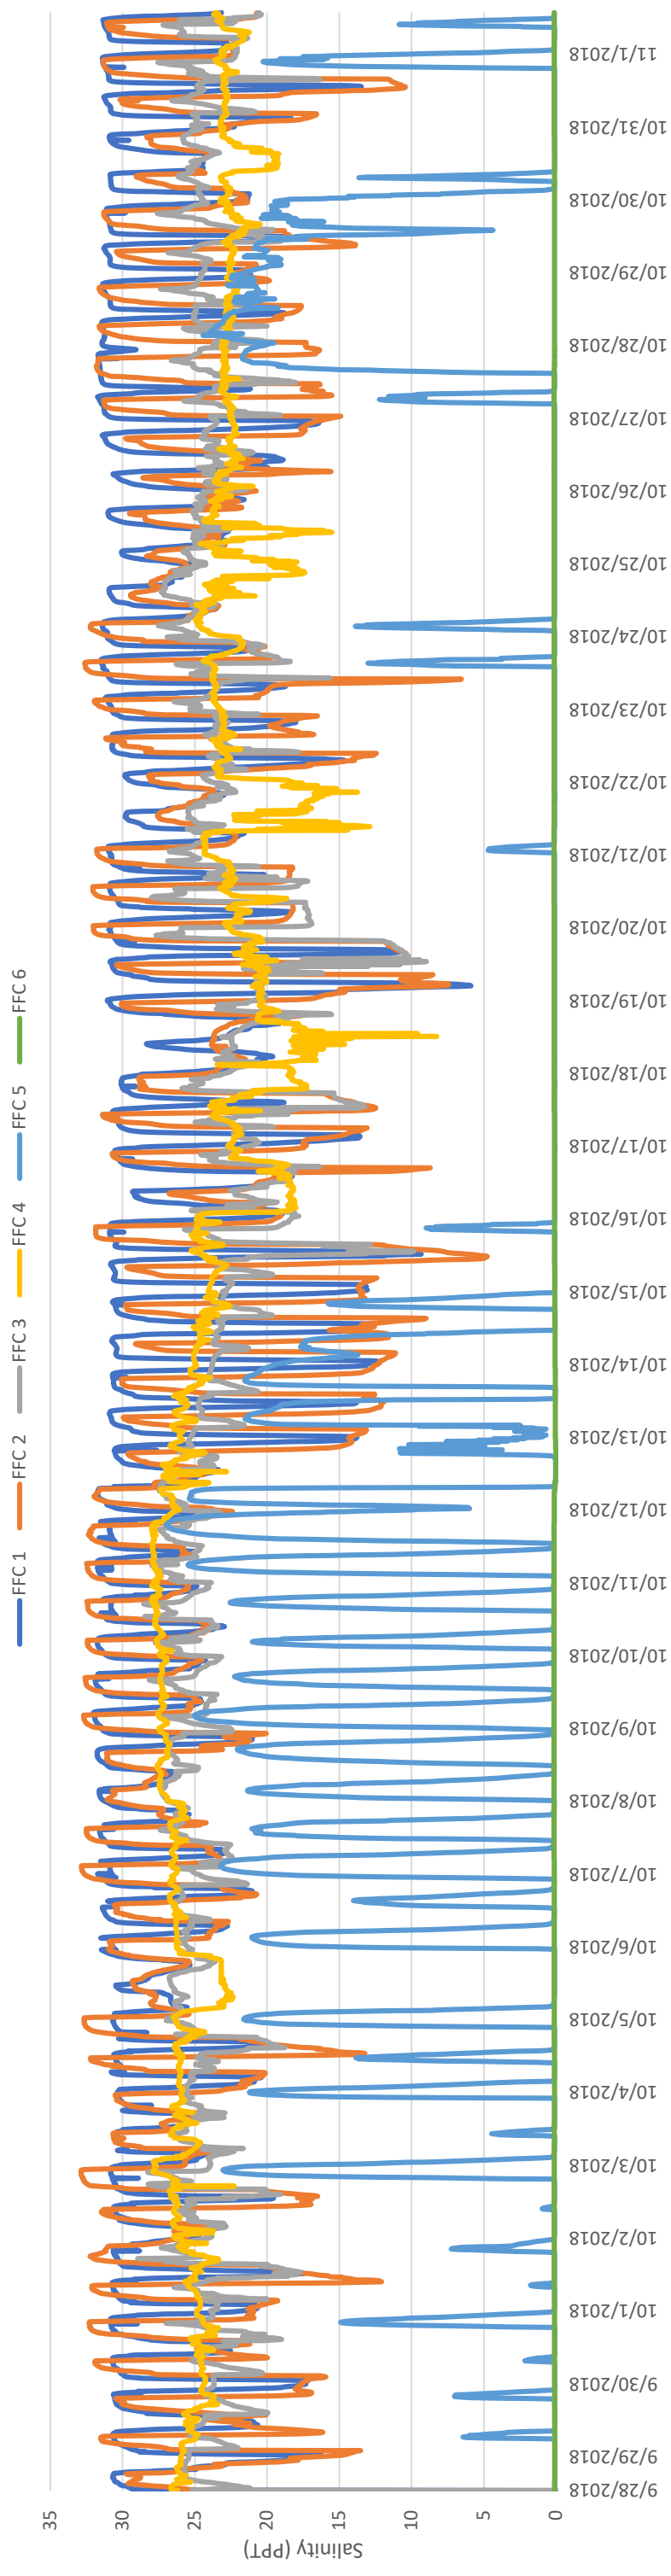
Frost Fish Creek Salinity North of Route 28 and at Various Points Further Upstream

Salinity data helped to confirm that tidal influence reaches as far upstream as FFC5 where the earthen berm separates Frost Fish Creek from the bog area. Looking at graphs of this data (Appendix E) it is apparent that water at FFC5 is primarily fresh until saline water reaches the area at the peak of the highest high tides, which does not occur during lower high tides. Salinity in the lower reaches of Frost Fish Creek (FFC2) and outside of the restricted area (FFC1) reach to nearly full oceanic salinity levels (35ppt) when incoming waters build toward high tides, while brackish salinity dominates during outgoing and low tides (15 to 30ppt). FFC3 and FFC4 in the middle sections of the Creek tended to remain consistently brackish in the range of 20 to 25ppt due to mixing of freshwater from the bog and salt from outside in the bay. As expected, water in the bog was fresh with only minor traces due to naturally existing mineral composition and potentially some salty stormwater runoff from roadways.
