Frost Fish Creek Restoration Assessment Report

Chatham, Massachusetts

January 3, 2019

Prepared by the Association to Preserve Cape Cod's Restoration Coordination Center
for the Chatham Conservation Foundation

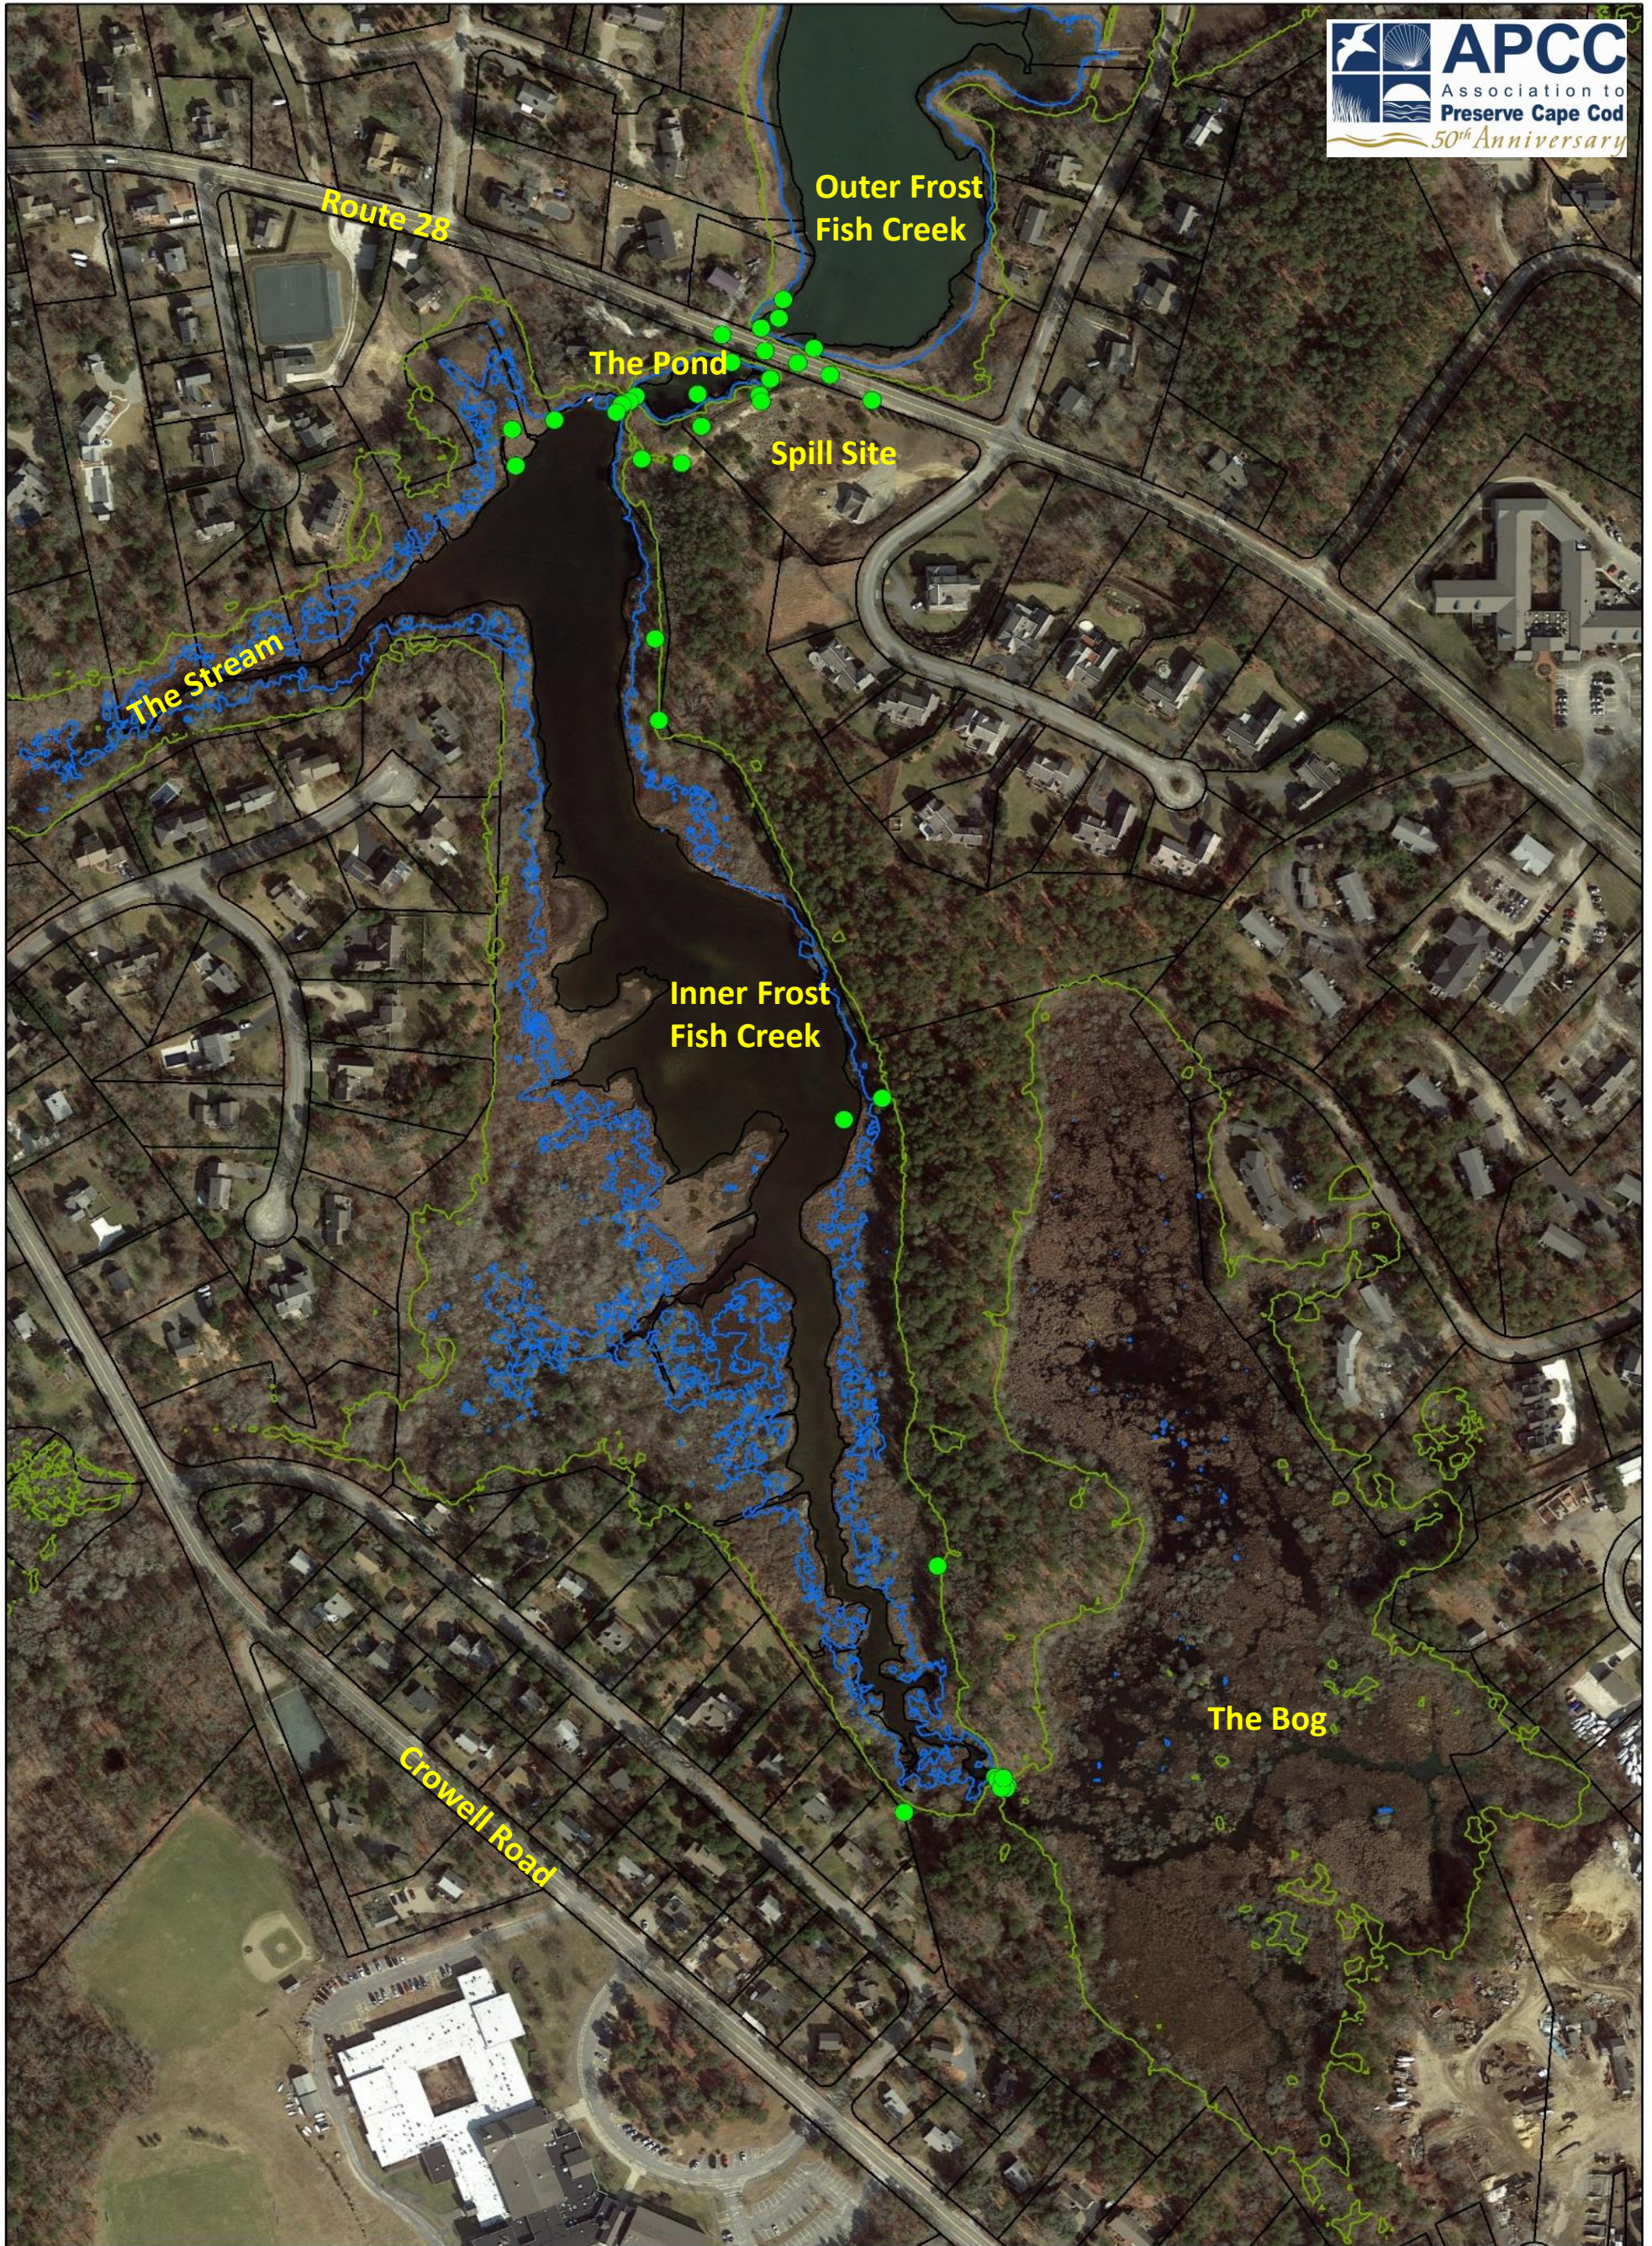
Appendix B. Elevation Survey Map

Assessment of land surface elevation throughout the Frost Fish Creek system was conducted both in the field, using an RTK GPS unit, and in the office, using ArcGIS Desktop software with various GIS data layers. The objective of the survey was to conduct a preliminary assessment of potential impacts of tidal restoration on low lying properties including impacts on existing vegetation communities, private properties, and other infrastructure. The GPS field survey also served to collect accurate measurements of data logger deployment elevations to allow calibration with the NAVD 1988 vertical datum and to document elevations of key components throughout the system including roadways, earthen berms, culverts, water control structures, and the toxic spill area at the site of the previous ACME Laundry business.

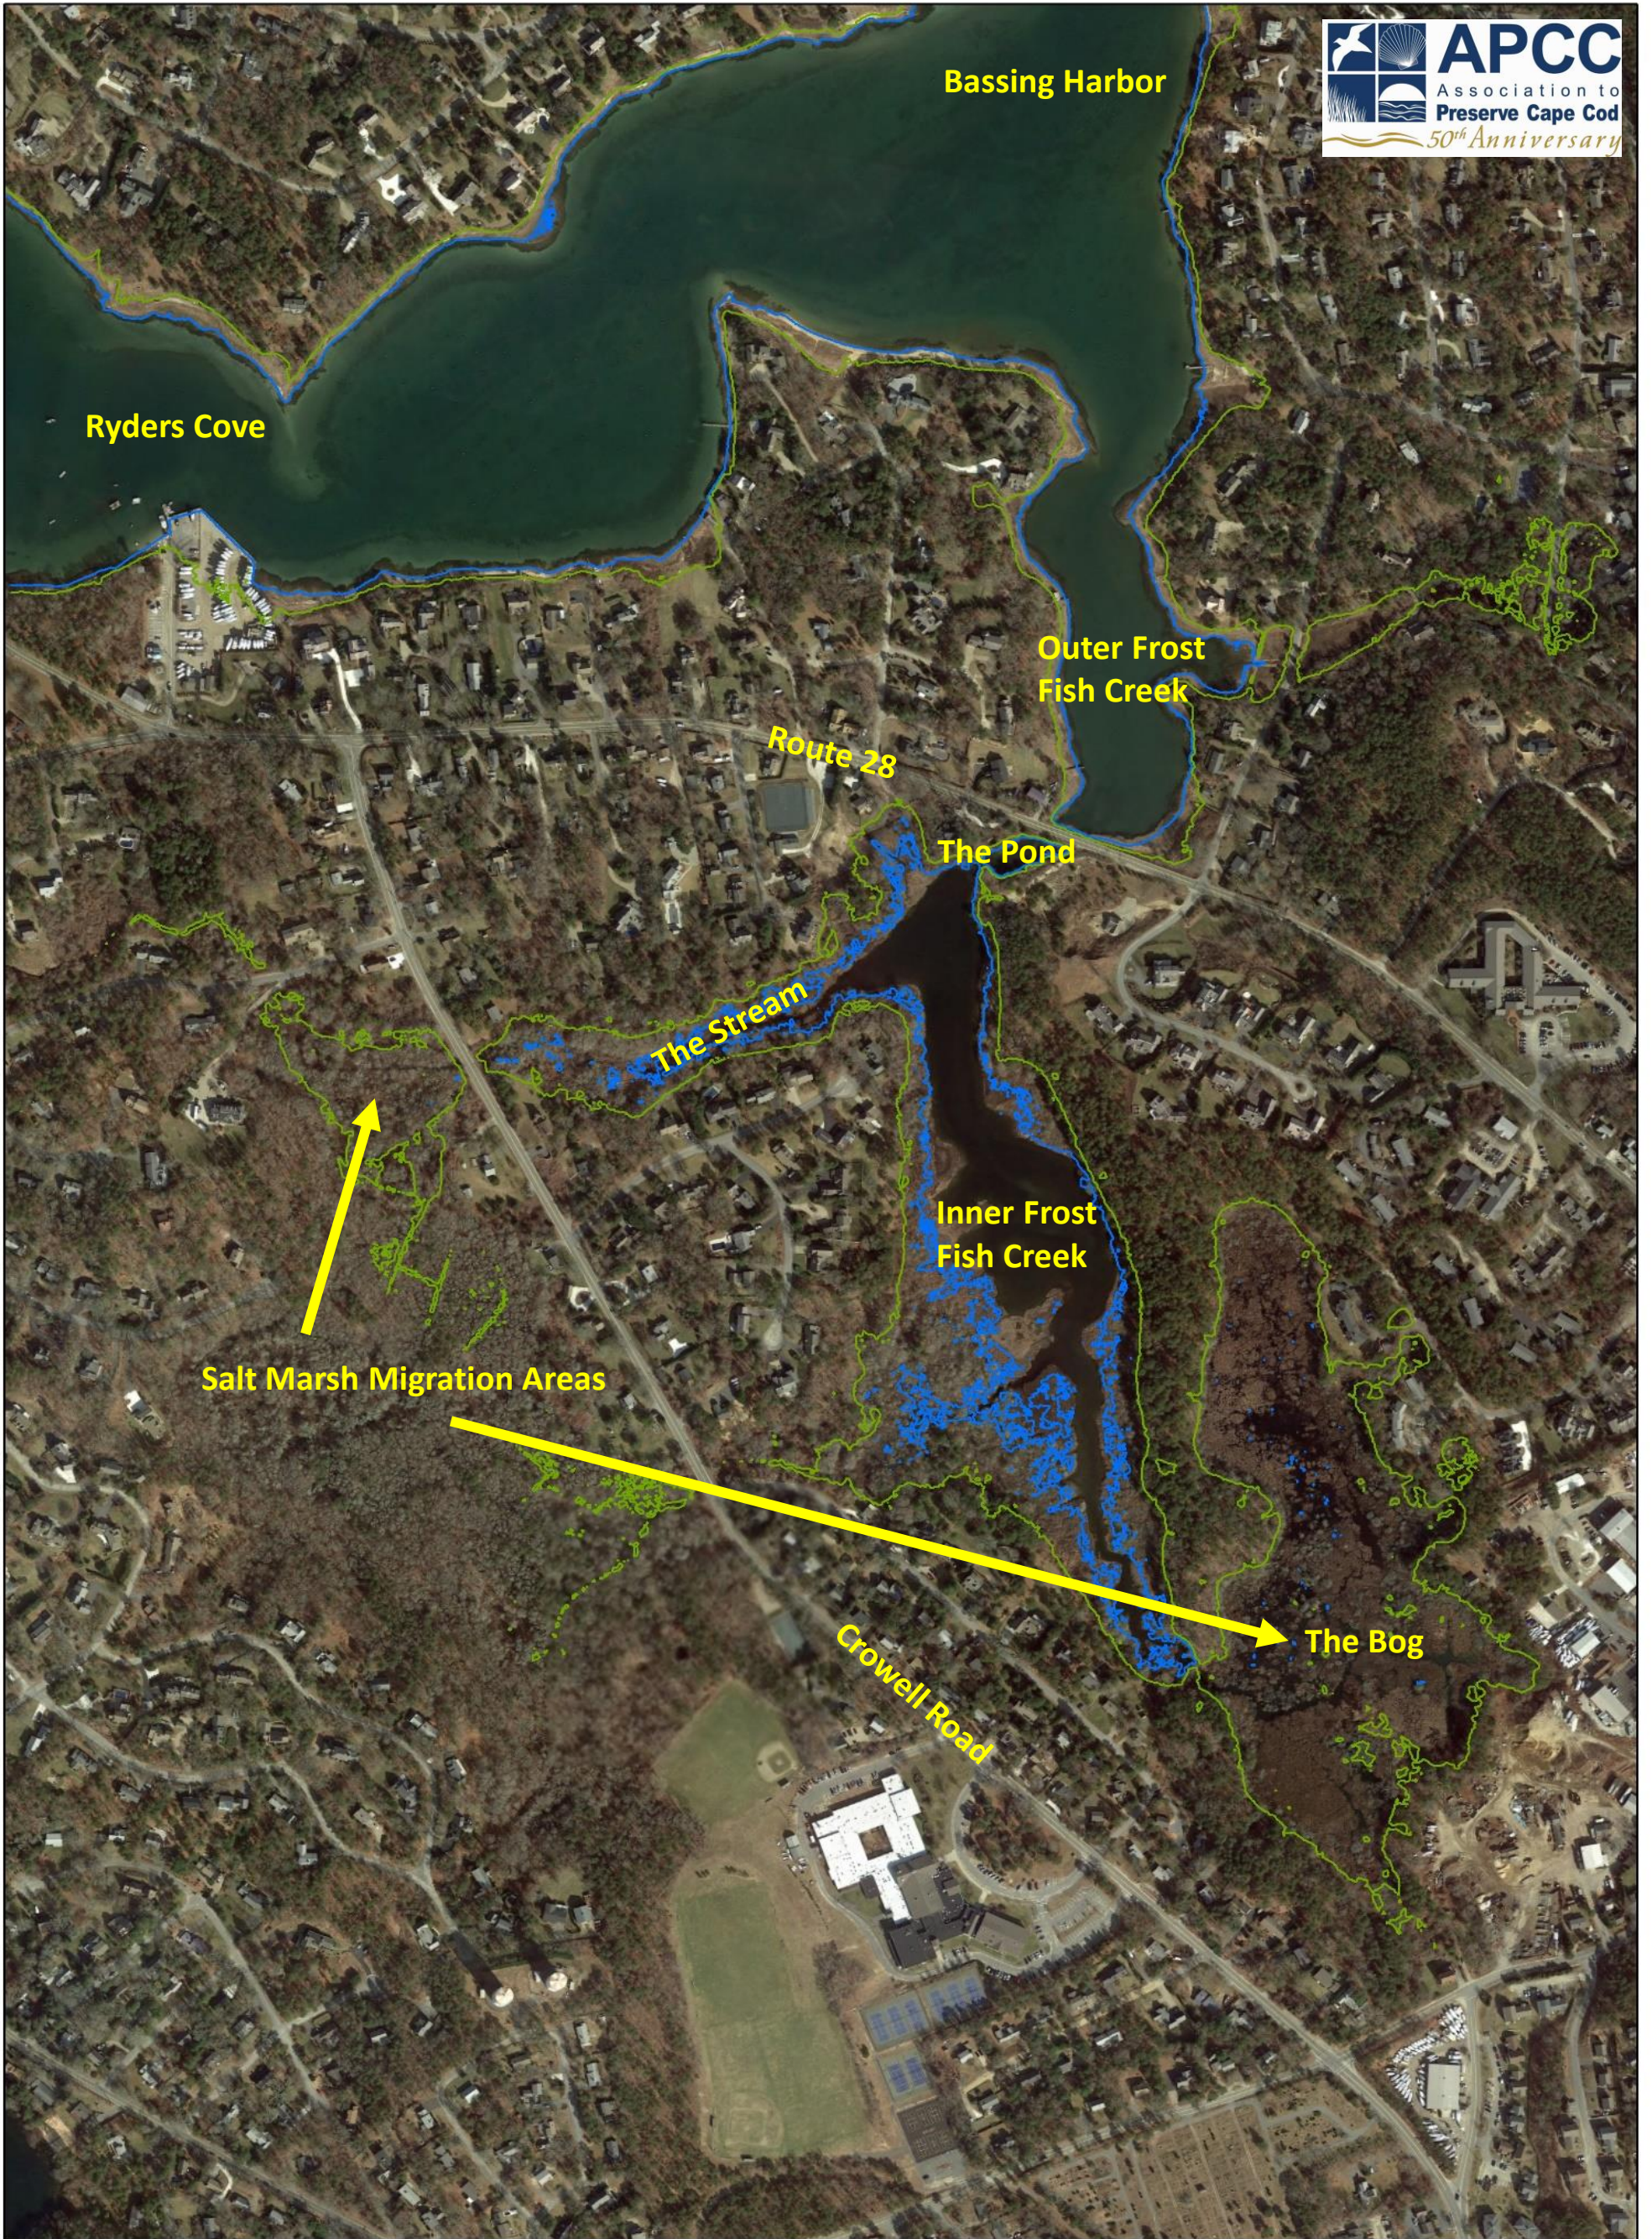
Appendix D. Salt Marsh Migration Map

Based on the range of WSEs documented during the time-series monitoring, LiDAR based topographic contour lines were derived at 2-ft and 5-ft above sea level relative to the NAVD88 vertical datum using ArcGIS Desktop software. The inclusion of the 5-ft contour line is intended to approximate this extreme high tide scenario for inner Frost Fish Creek. An Elevation Survey Map (Appendix B) and Salt Marsh Migration Map (Appendix D) were created with these contour lines to allow visual examination to identify potential low-lying property conflicts and marsh migration locations throughout the project area. Working with the project file in ArcGIS, or using the town GIS webmap, the addresses and ownership of low-lying parcels can be obtained.

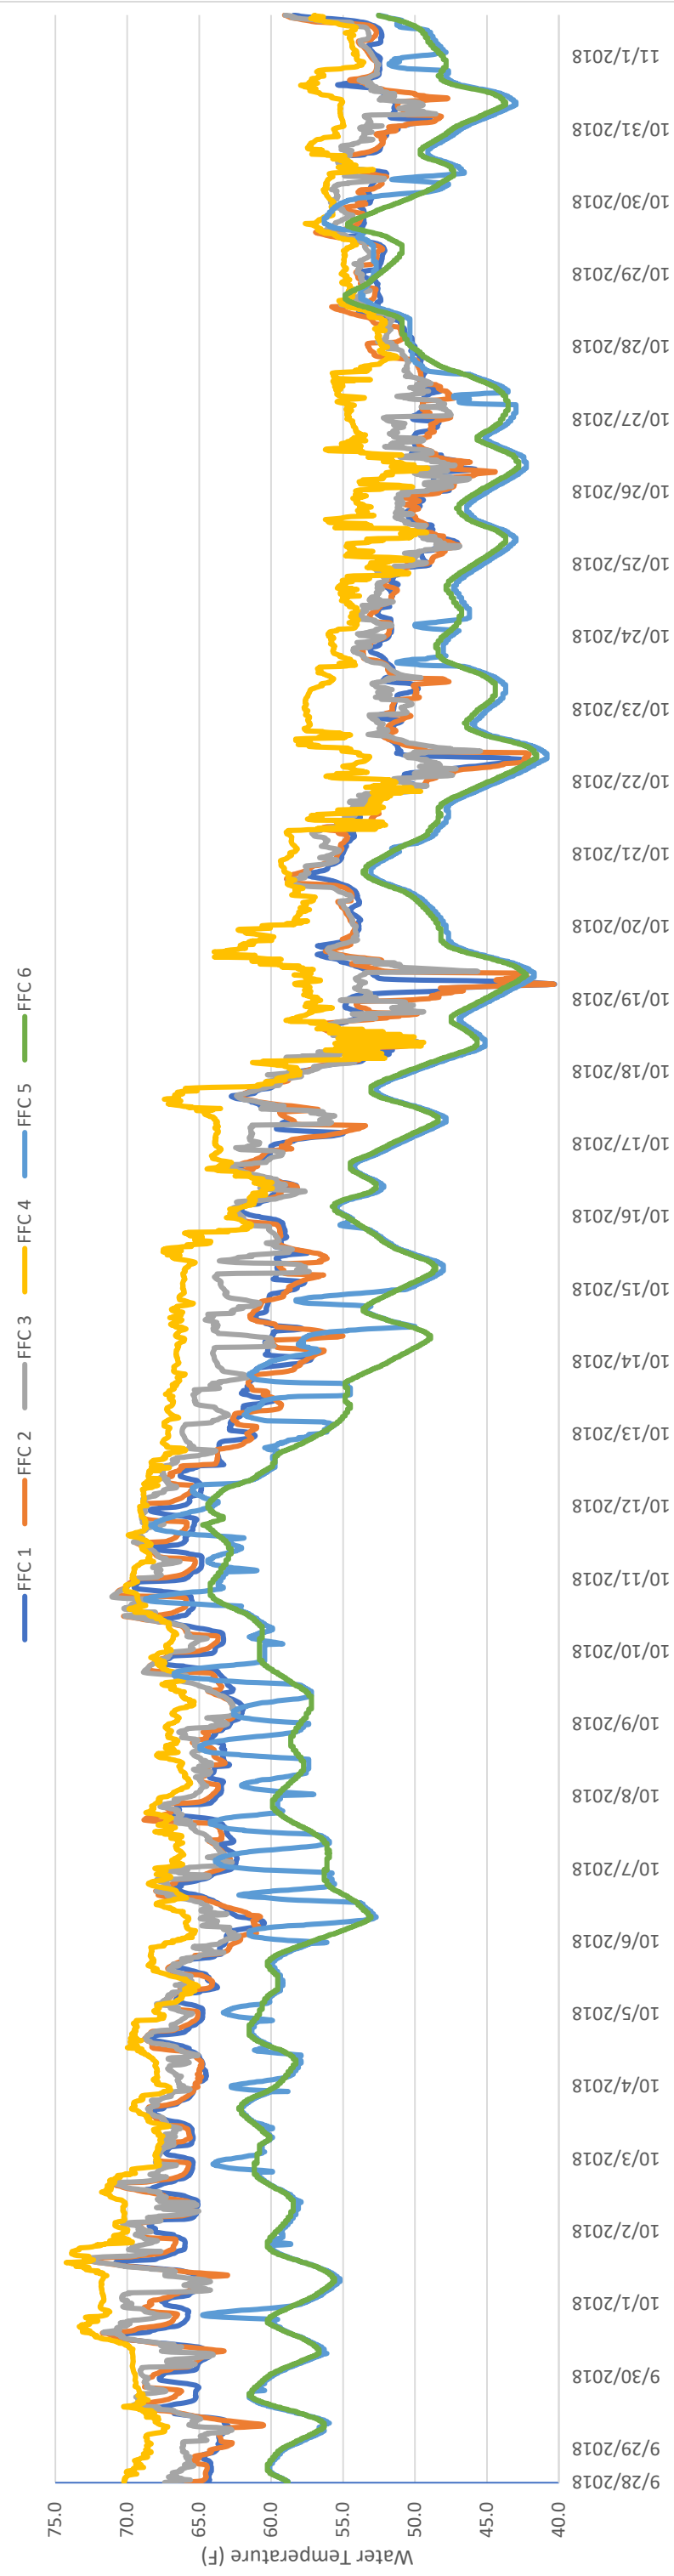
Frost Fish Creek Salinity North of Route 28 and at Various Points Further Upstream

Salinity data helped to confirm that tidal influence reaches as far upstream as FFC5 where the earthen berm separates Frost Fish Creek from the bog area. Looking at graphs of this data (Appendix E) it is apparent that water at FFC5 is primarily fresh until saline water reaches the area at the peak of the highest high tides, which does not occur during lower high tides. Salinity in the lower reaches of Frost Fish Creek (FFC2) and outside of the restricted area (FFC1) reach to nearly full oceanic salinity levels (35ppt) when incoming waters build toward high tides, while brackish salinity dominates during outgoing and low tides (15 to 30ppt). FFC3 and FFC4 in the middle sections of the Creek tended to remain consistently brackish in the range of 20 to 25ppt due to mixing of freshwater from the bog and salt from outside in the bay. As expected, water in the bog was fresh with only minor traces due to naturally existing mineral composition and potentially some salty stormwater runoff from roadways.

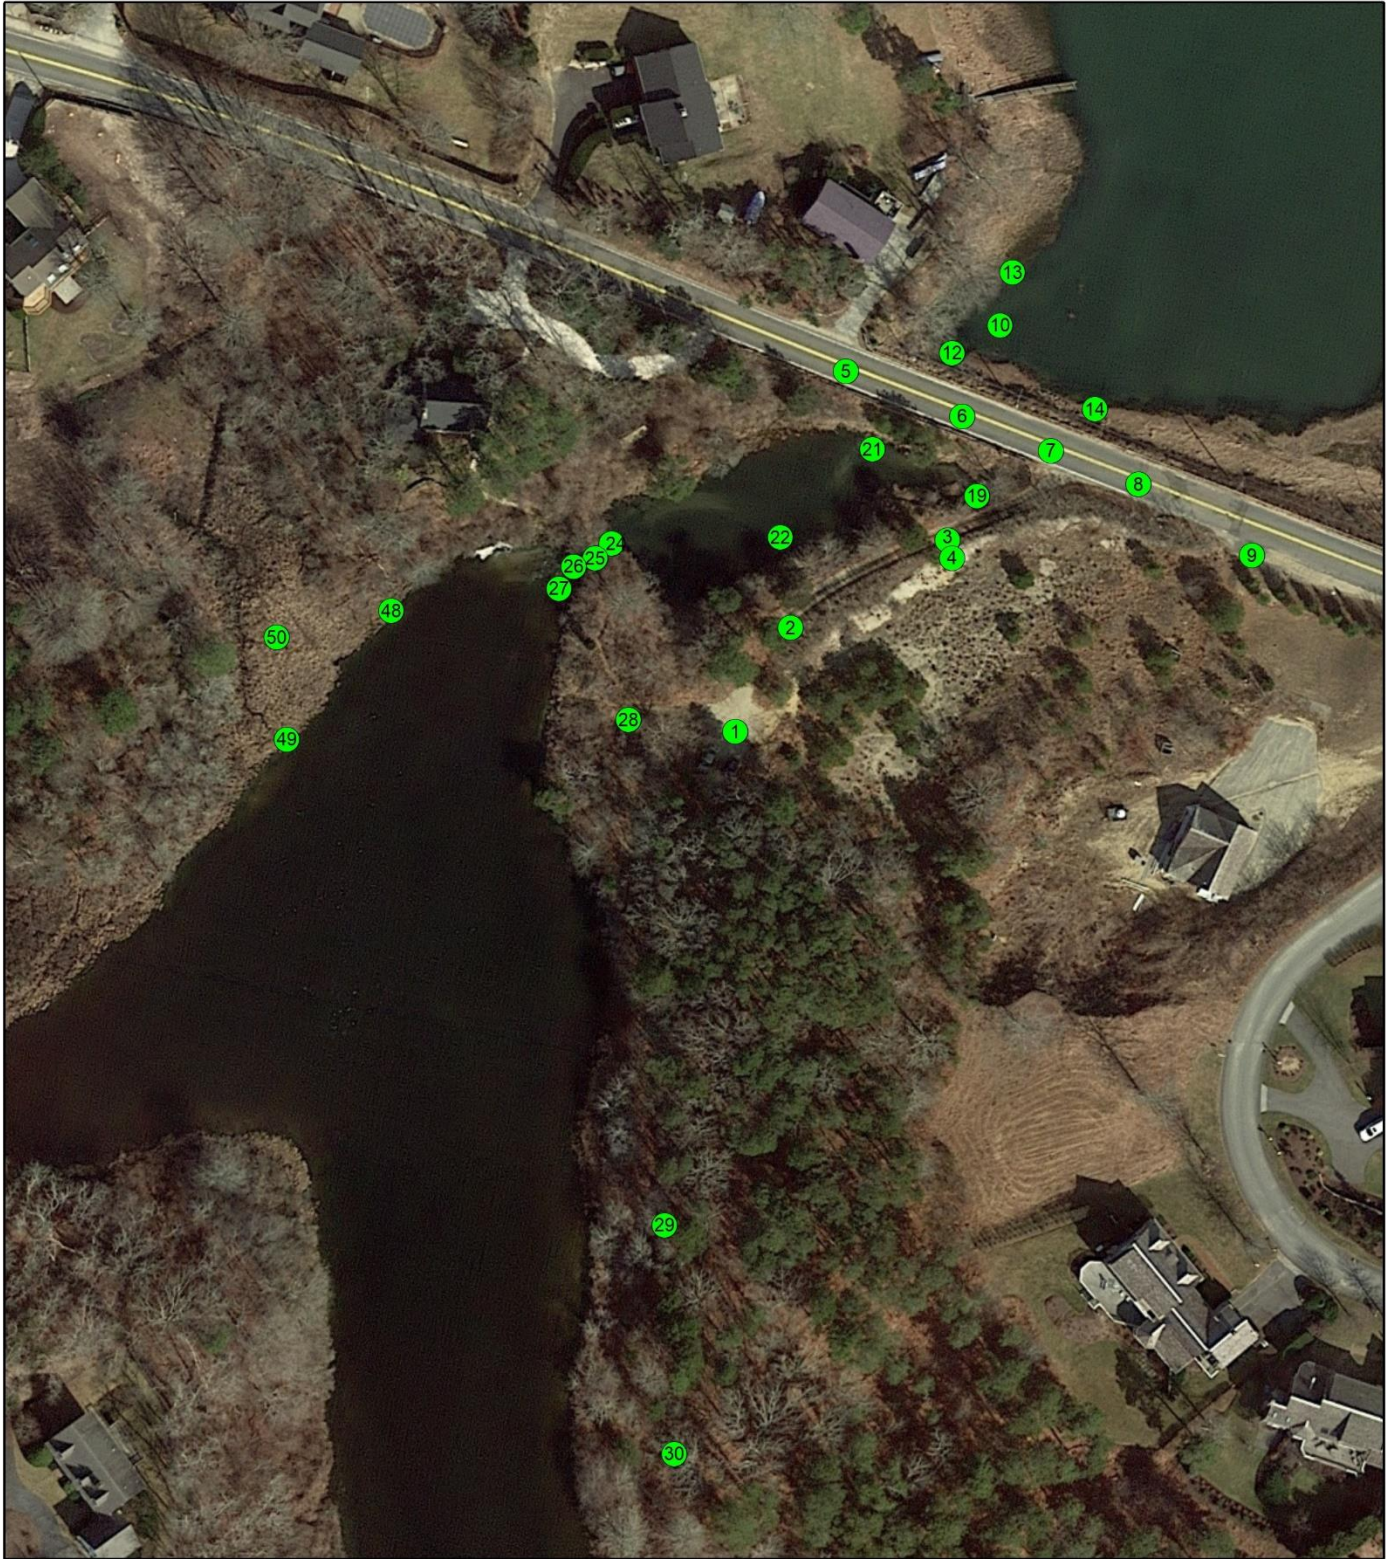
**Elevation Survey Points
Northern Frost Fish Creek**

Points 1-47 collected by Dan Mackenzie of Horsley Witten Group using RTK GPS. Points 48-50 collected by Bryan Horsley of APCC using auto level in reference to point 26 on southeast corner of concrete headwall structure.

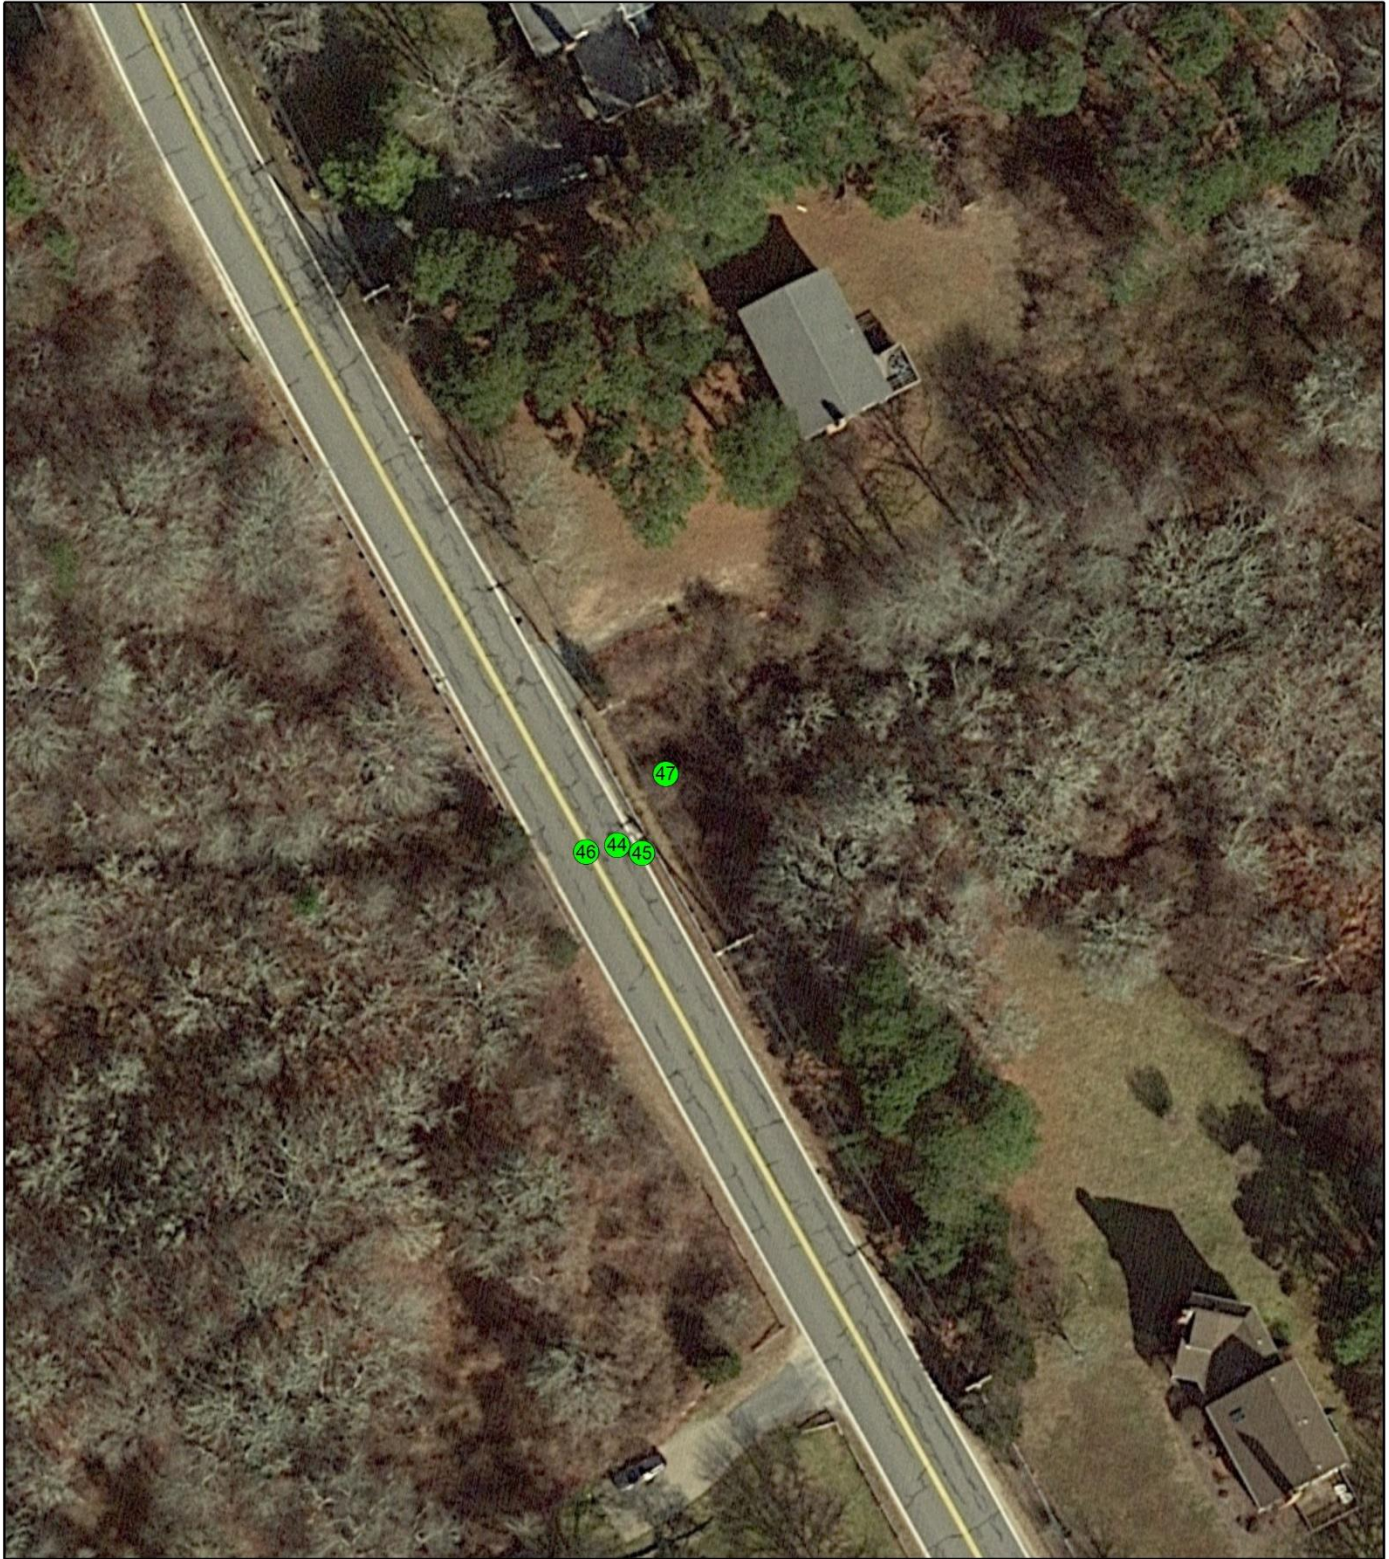
Elevation Survey Points
Stream Crossing of Crowell Road
Western Frost Fish Creek

Points collected by Dan Mackenzie of Horsley Witten Group using RTK GPS.

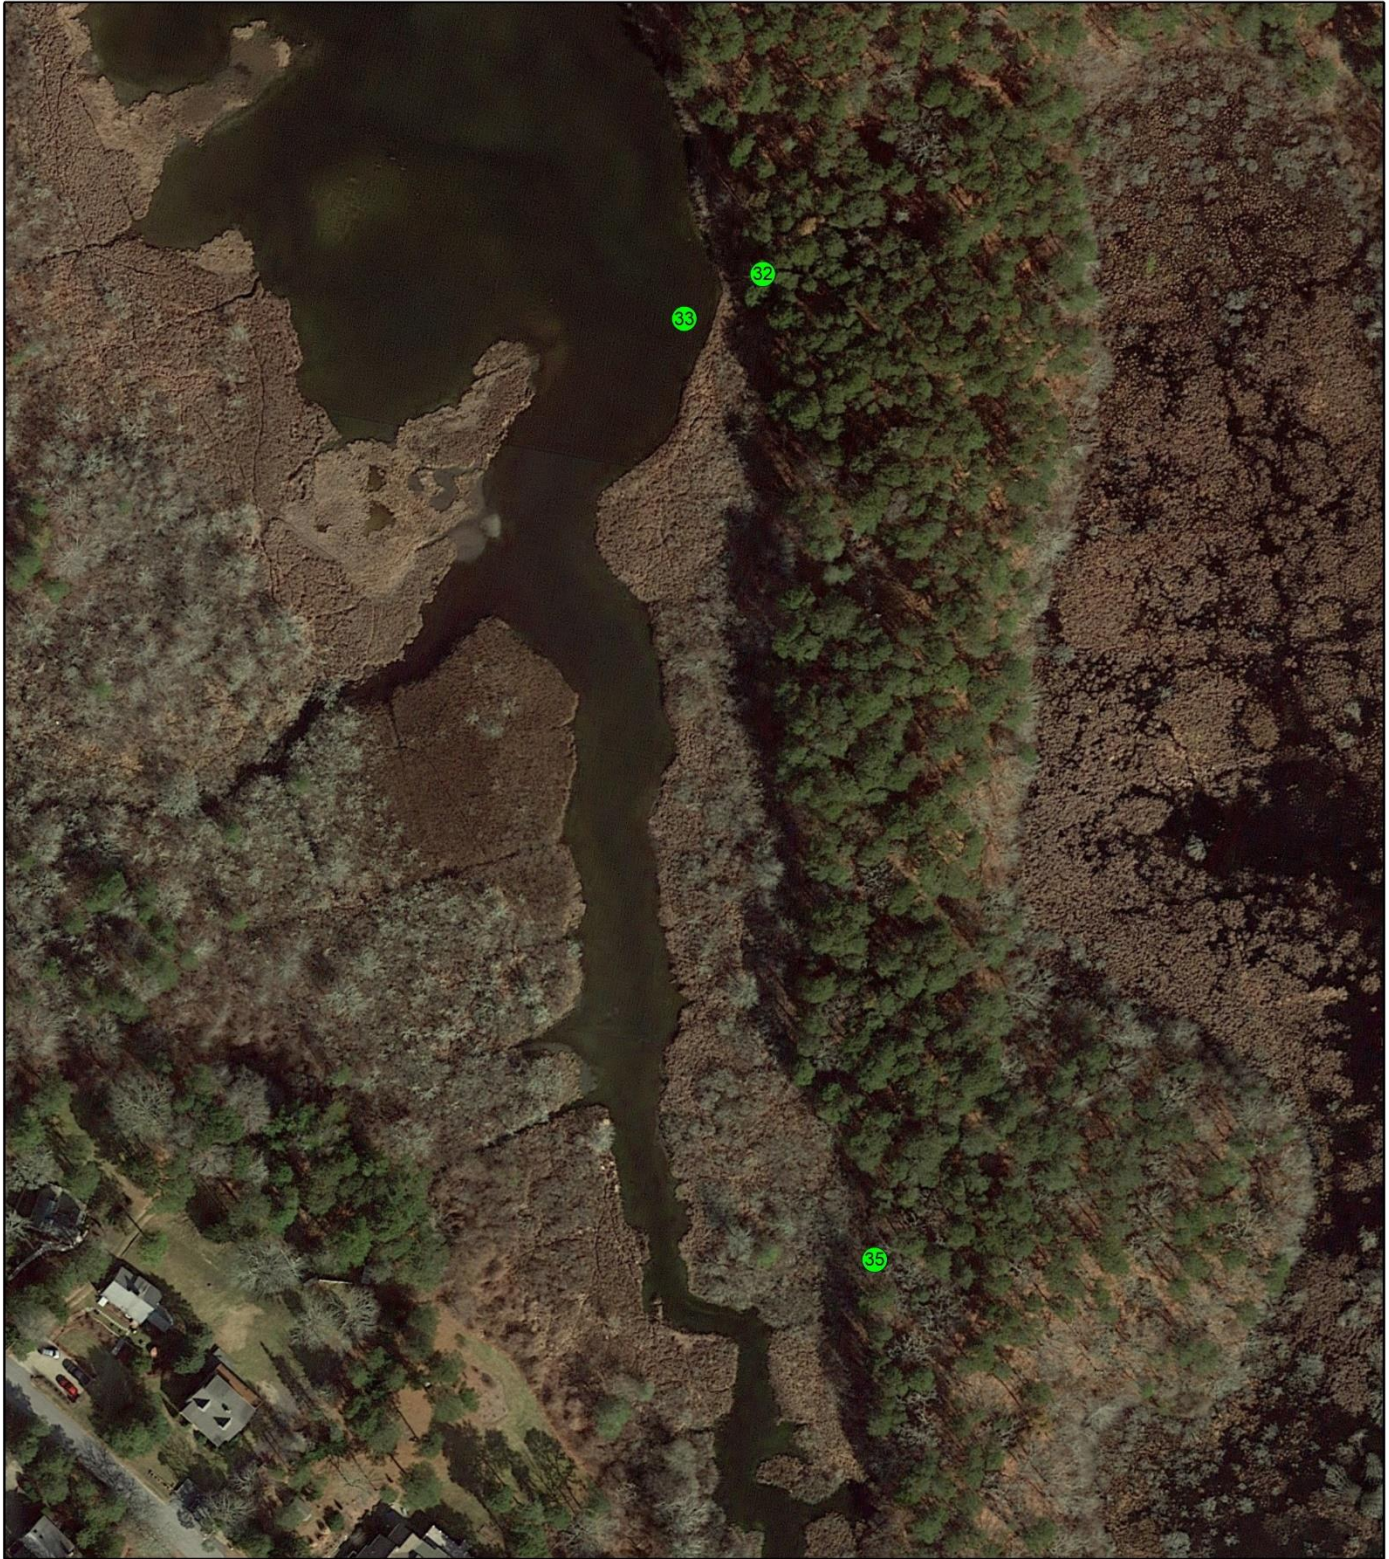
**Elevation Survey Points
Mid Frost Fish Creek**

Points collected by Dan Mackenzie of Horsley
Witten Group using RTK GPS.

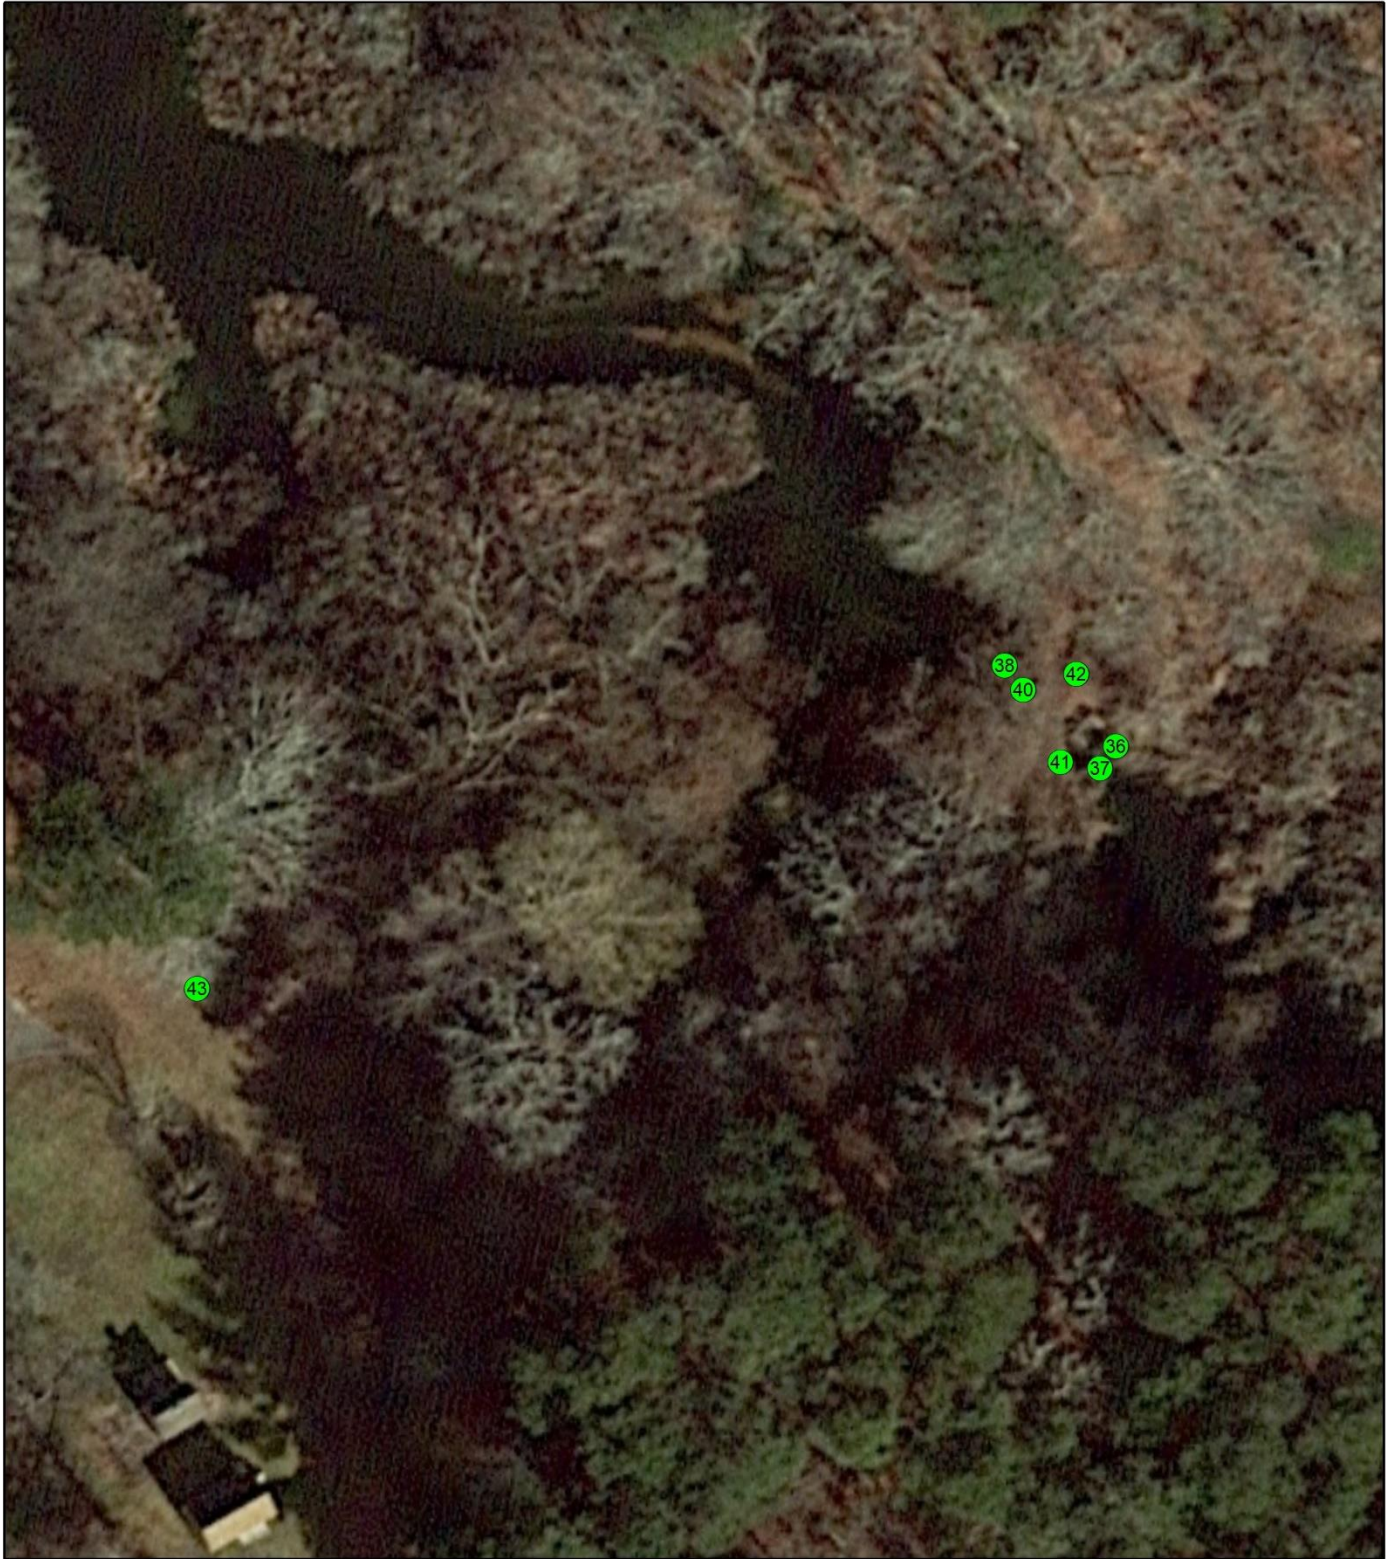
**Elevation Survey Points
Southern Frost Fish Creek**

Points collected by Dan Mackenzie of Horsley
Witten Group using RTK GPS.
